Manhole Inspection Summary

Manhole # S49A__035MH

Inspection ☐ Is Incomplete Rating: **5) Immediate Attention Required**

Location Address: **front corner 401 n lakewood av** Cross Street: **orleans st**

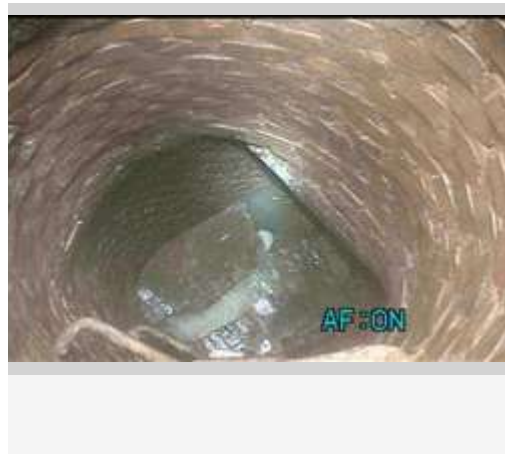
Top View

Chimney / Frame Adjustment ☒ Exists Material: **Brick and Concrete** ☐ Parged Height: **7.5** (in.)
Condition: ☐ Sound ☐ Cracked ☐ Root Intrusion ☒ **Loose Brick** ☒ **Deteriorated**
Infiltration: ☐ None ☒ **Joint** ☐ Cracks ☒ **Mortar** ☐ Roots ☐ Wall

Corbel Material: **Brick** ☐ Parged Type: **Concentric/Eccentric**
Condition: ☐ Sound ☒ **Cracked** ☐ Root Intrusion ☐ Loose Brick ☐ Deteriorated
Infiltration: ☒ None ☐ Joint ☐ Cracks ☐ Mortar ☐ Roots ☐ Wall

Bench ☒ Exists Material: **Brick** ☐ Parged
Condition: ☐ Sound ☐ Cracked ☐ Root Intrusion ☐ Deteriorated ☐ Leaks ☒ **Debris**

Channel Material: **Brick** ☐ Parged
Channel Exposure: **Fully Open** Junc Dist: **0** nearest .5 ft. Azimuth: **0**
Condition: ☐ Sound ☐ Cracked ☐ Root Intrusion ☐ Deteriorated ☐ Leaks ☒ **Debris**

Steps Count: **11** Missing: **1** ☒ **Corroded**

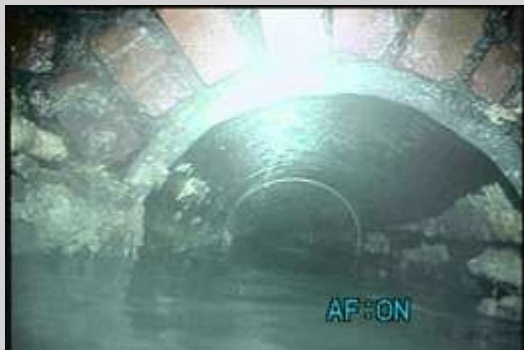
12 O'Clock Outflow

15 in. Circular Gravity Sewer
Pipe Out @ 12 O'Clock

Pipe Material: **Clay** ☐ Pipe Lined

Infiltration: **None** Pipe Seal Cond: **Unknown**
